*Creosote treated piling
-perceptions versus reality-*

Creosote treated piling in Sooke Basin

By Dr. Kenneth M. Brooks

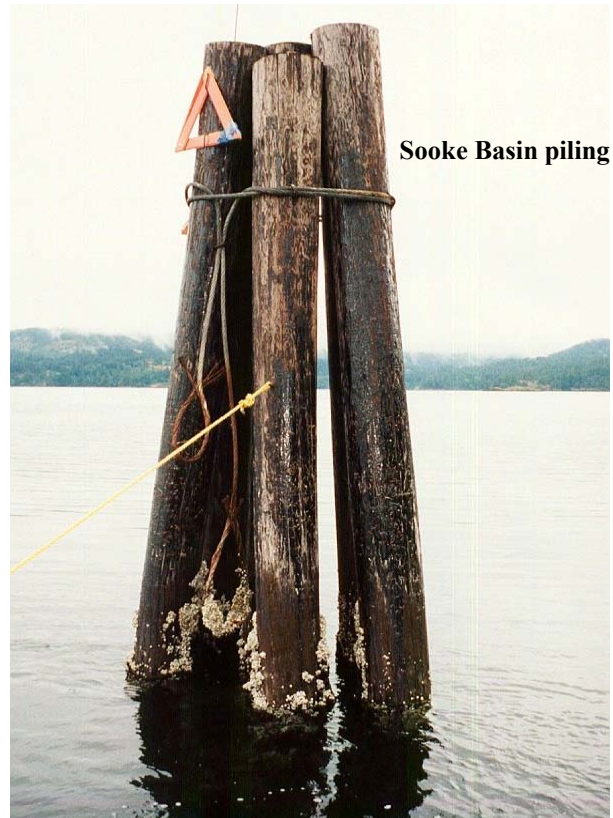
Sooke Basin piling

My efforts over the last 12 years have been to shed light on the environmental response to pressure treated wood and to develop predictive models useful in insuring that their long history of safe use is not interrupted in the future. In all of these efforts, the approach has been to study and model *worst cases* in an effort to see adverse effects should they be present. In 1994, the Canadian government undertook studies to determine how creosote treated wood affects marine environments. The *Sooke Basin Study*, completed by myself and Dr. Darcy Goyette from Environment Canada lasted five years and compared the environmental response to newly treated (shown above) and 8 year old creosote treated piling with untreated Douglas fir piling.

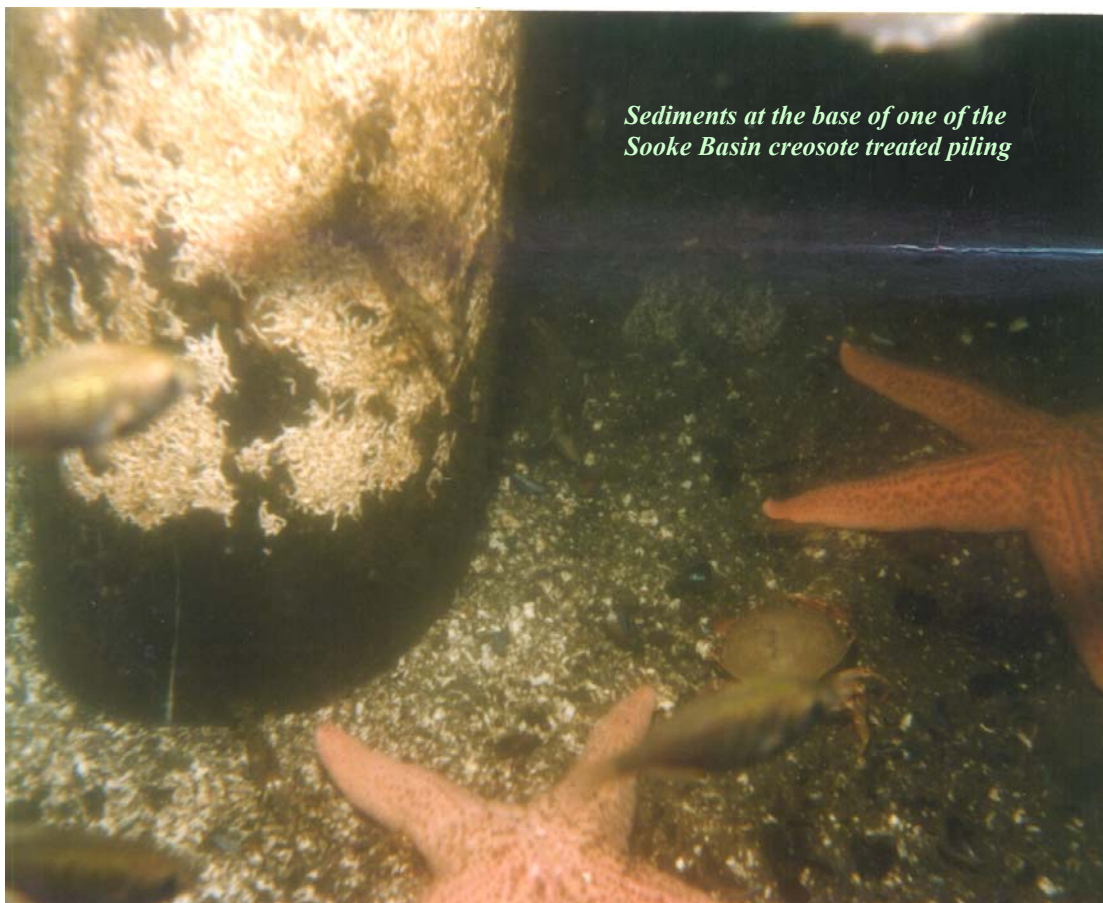
Sophisticated methods were used to measure dissolved concentrations of PAH in the water column at Sooke basin within six inches of the downcurrent most piling. The concentrations, found to be about 20 parts per trillion, were not higher than found at the

reference station where there was no treated wood. In contrast, measurably increased concentrations of PAH were found in the sediments within about 30 feet of the piling. At the base of the piling, these concentrations reached levels where they might affect particularly sensitive invertebrates living in the sediments (infauna). However, repeated inventories of the infaunal community revealed no significant adverse effects. About 1,000 days following construction, computer models predict that the loss of new

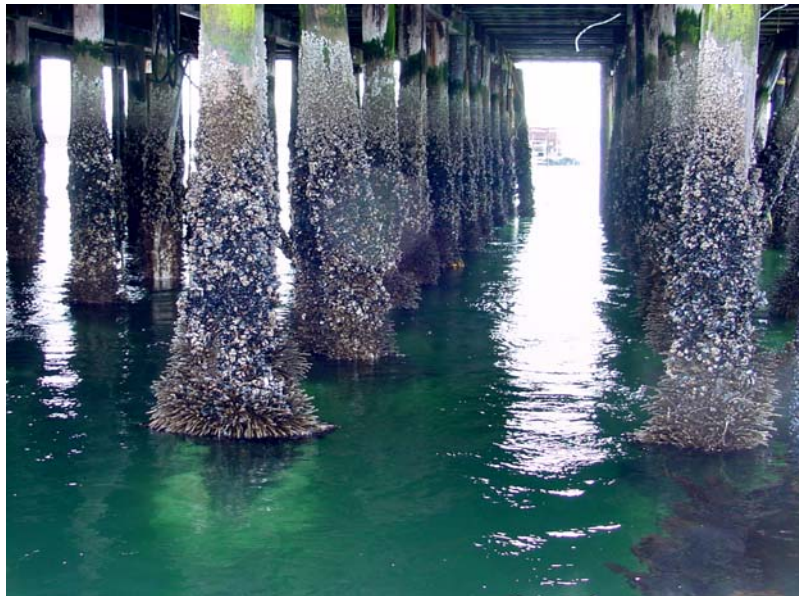
around larger structures and to further evaluate the uptake of PAH from creosote treated wood to blue mussels. Sediment and invertebrate samples were collected at four sites in Puget Sound. The smallest structure examined was Port Townsend, Washington's municipal pier having 82 piling. The pier and wharf at Fort Ward in Rich passage (above) included to a 410' long x 20' wide pier and an 80' x

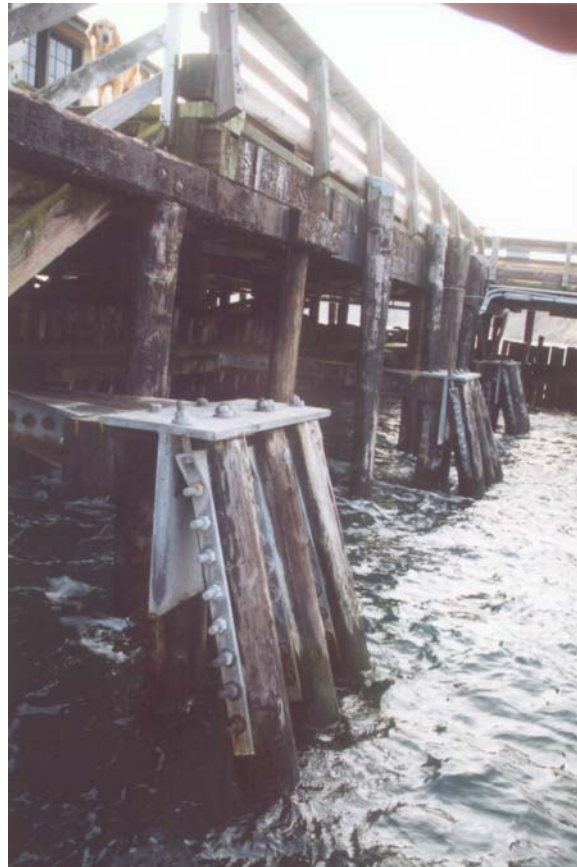
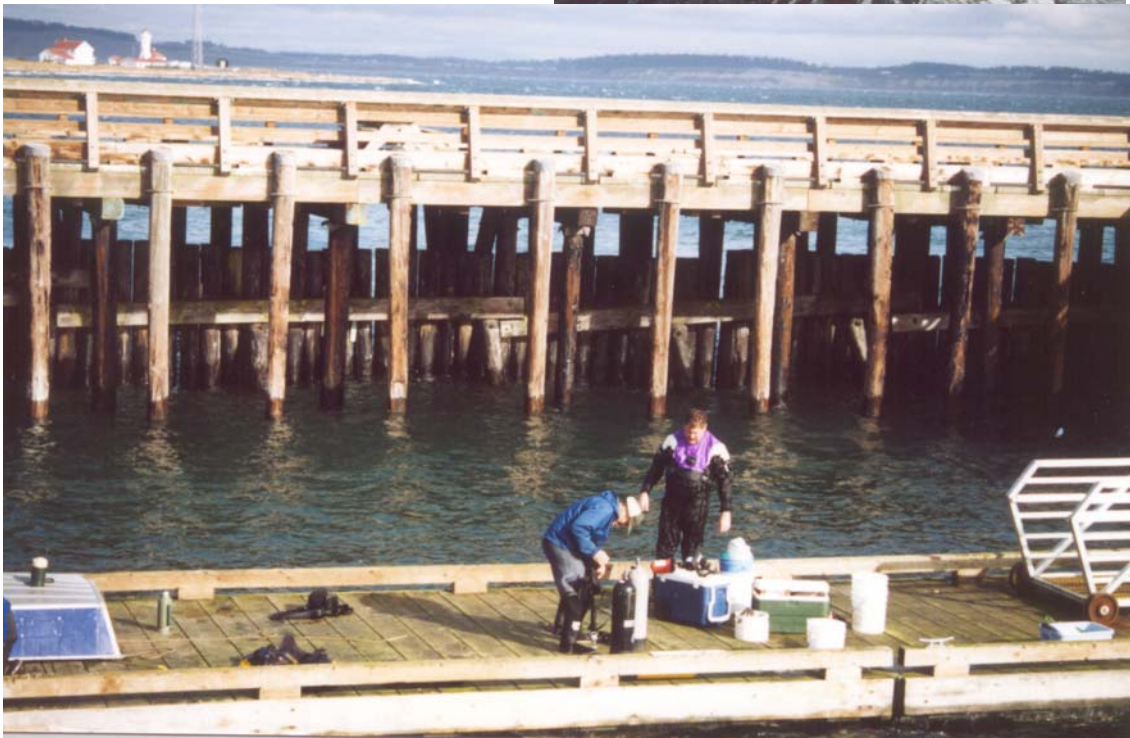
110' wharf (below). These structures were supported on 284 creosote treated pilings that were generally spaced ten feet apart in each direction. The most densely packed structure was the old ammunition wharf at Fort Worden in Port Townsend, which is currently home to the city's Marine Science Center. The wharf covers 18,995 square feet and the 20' wide pier is 362 feet long. The wharf and pier are protected on their perimeters by a continuous wave breaking fence construction of creosote treated piling. Over 800 creosote treated piling are used at Fort Worden. In addition to the piling there are large numbers of creosote treated braces and support beams. As previously noted, structures of this size are no longer typically constructed of creosote treated piling. However, their analysis is considered important in understanding the range of effects that could be expected from the use of creosote treated wood.

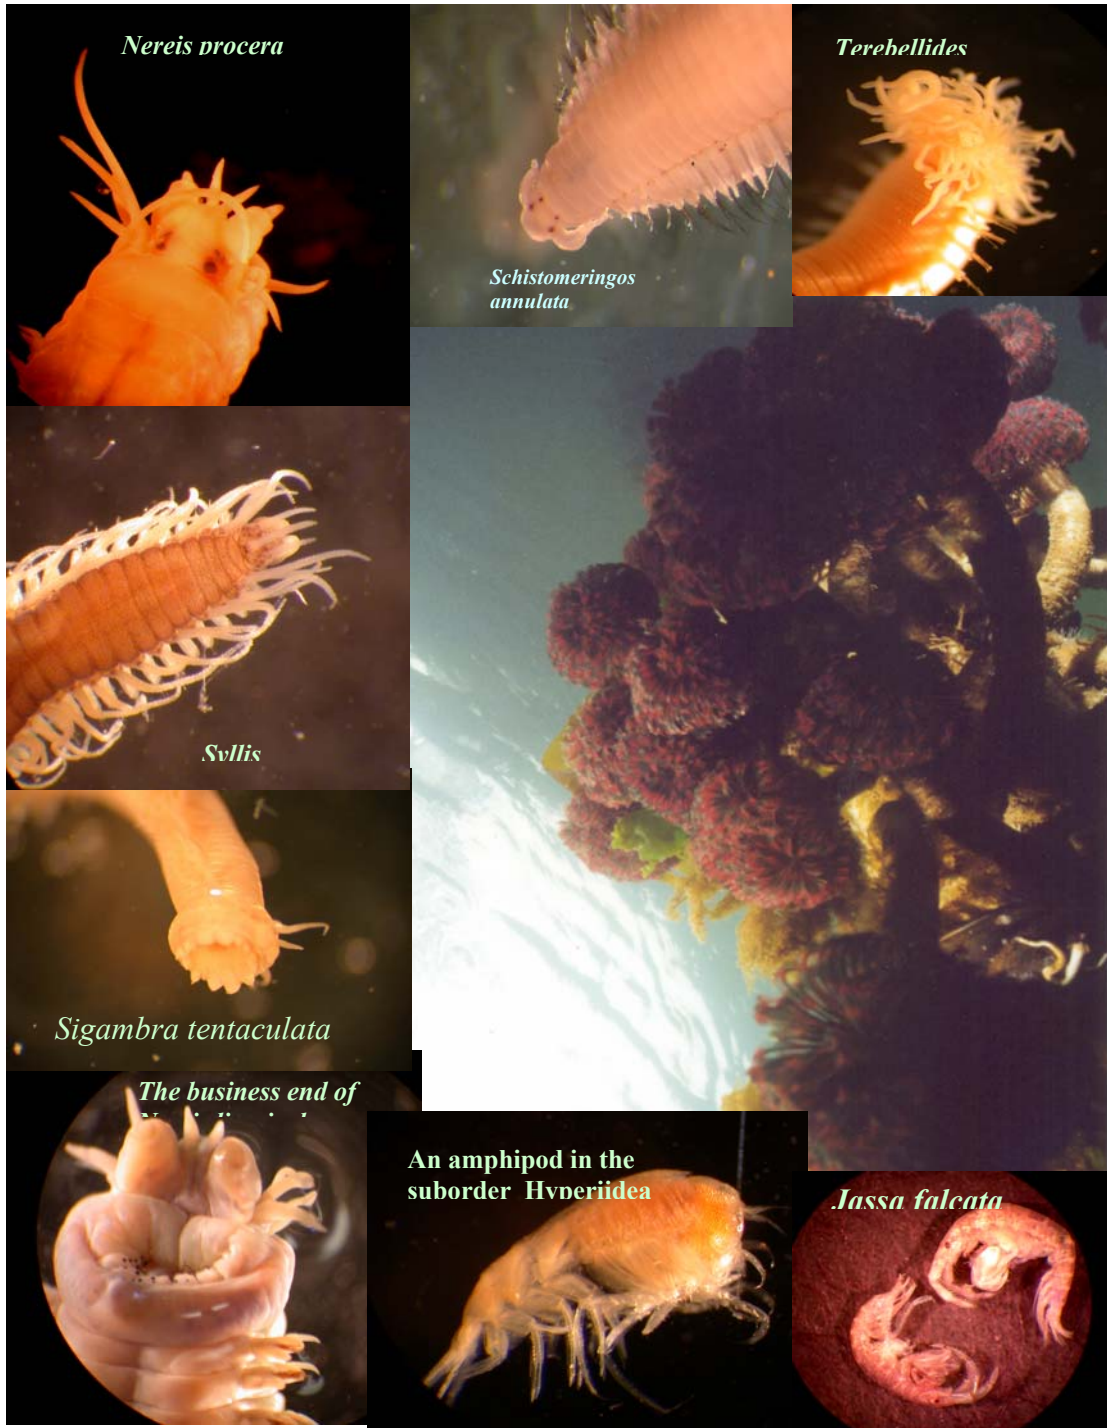
top of the previous page and ten other types of animals like the white plumose anemones behind the crab and the beautifully colored *Tealia crassicornis* at lower left on the previous page. Most of the animals living on creosote treated piling are too small to be seen clearly with the naked eye. But as seen below, buried in the habitat created by larger animals is an entire community of small living creatures that find refuge and food in this complex environment.
